## Applications

| Application | Detection of lettuce heads on a conveyor |
| Product | LT/LR |

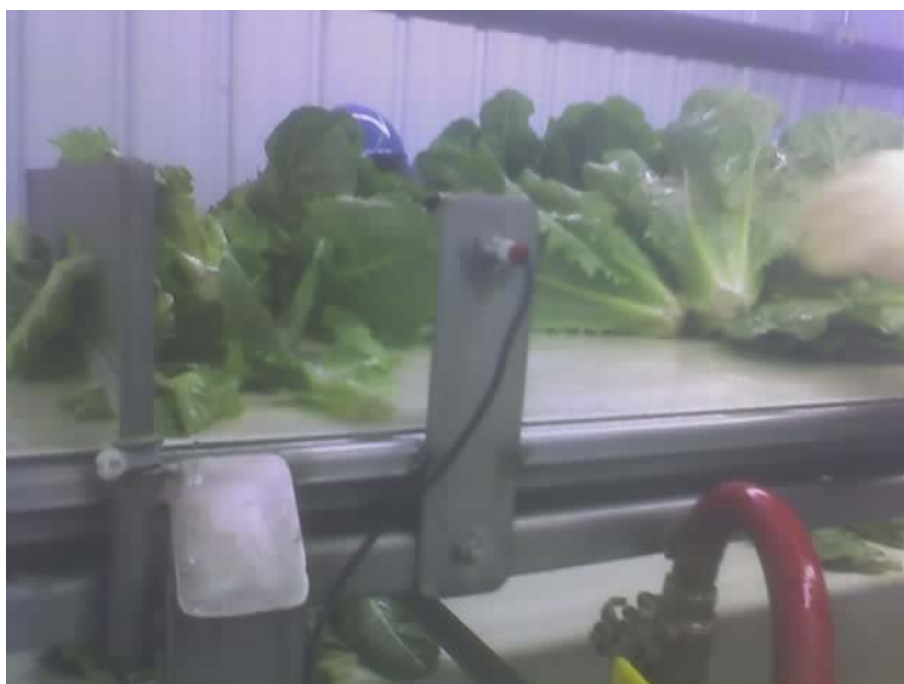
The LT/LR sensors are mounted along the side of a conveyor belt transporting lettuce heads. Heavy water spray on the lettuces caused the previous sensors to fail and the lettuce leaves that came off during transport on the conveyor frequently blocked the sensors causing down time. With Telco this does not happen and they continue working despite the water and the leaves that block the sensors.
