## Applications

| Customer Group | Furniture – Gluing station |
| Product | PA 11 + LT/LR 100 |

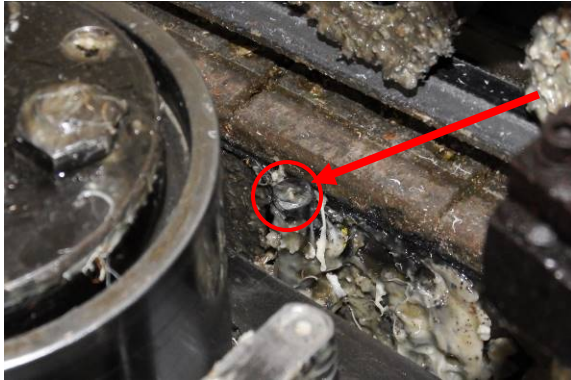
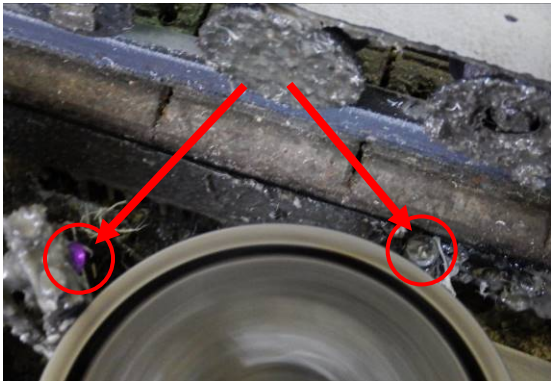
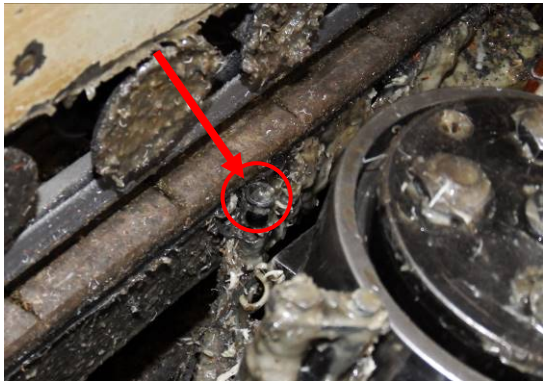
| <p>Details</p> <p>LT and LR sensors installed in a gluing station of furniture production. They cannot be cleaned and therefore they have to be replaced after a certain time due to the accumulation of glue on the sensor lenses.</p> <p>Surprisingly, they work for up to two years before having to be replaced.</p> | |
